ROAD SAFETY AUDIT

Title: STAGE 1 ROAD SAFETY AUDIT

Office Innovation Campus, Moygaddy, Co. Meath.

Report reference: 1388R01

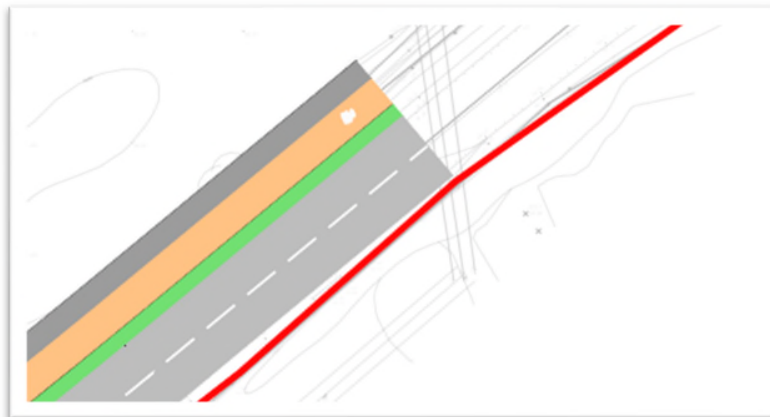
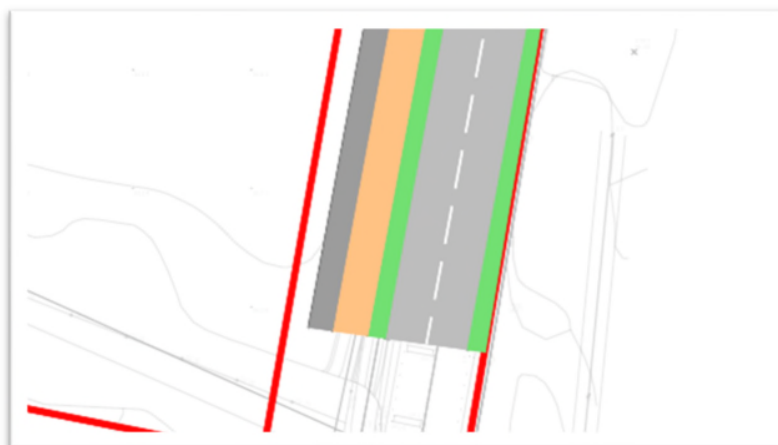
3.1 Problem

General Comment tie-in points

Details have not been provided of how the cycle track and footpaths will tie in at the scheme extents. Cyclists and pedestrians will have to cross the carriageway to access the facilities. Without suitable transitions from off road to on road and suitable crossing facilities there is a risk that pedestrians and cyclists will be struck by passing traffic.

Examples only

It is recommended that suitable transitions and crossing facilities be provided.

3.1	Y	Y	The proposed cycle lane along the R157 eastern arm will be updated to tie into the carriageway. A suitable Jug turn will be provided on the opposite side of the road to accommodate the cyclists' right turning movement towards the development	Yes

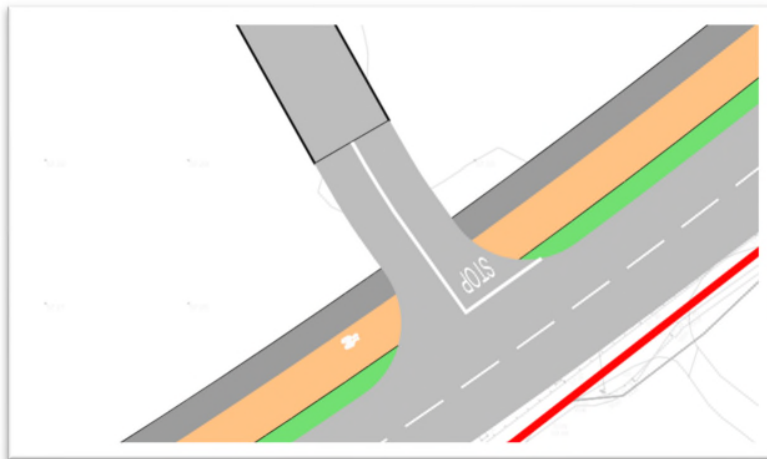
3.2 Problem

Drawing S665- OCSC-1A-MH-DR-C-0111 S2 P01 Sheet 2 of 3, cycle track across campus access road.

The proposed two way cycle track crosses the mouth of the campus access road. There is a risk that drivers exiting the campus may not expect two way cyclists as they approach the stop line.

It is recommended that a 'bend out crossing' be provided.

3.2	Y	N	It is proposed to provide a shared space and tactile for crossing before the cyclist and pedestrians approach the junction. A raised crossing will be provided to indicate priority for pedestrians and cyclists.	Yes

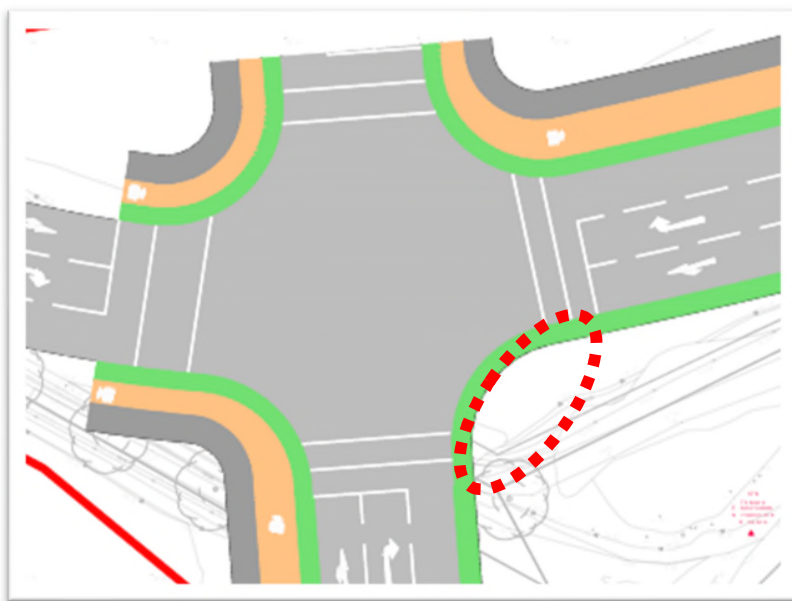
3.4 Problem

Drawing S665- OCSC-1A-MH-DR-C-0111 S2 P01 Sheet 2 of 3, campus access road.

There is a signalised pedestrian crossing of the R157 eastern section, however there is no footpath on that side. This could lead to slips and falls if pedestrians cross into the grassed verge.

It is recommended that a section of footpath be provided linking the north-south and east west pedestrian crossing areas. The crossing should be retained to be able to cater for potential future development.

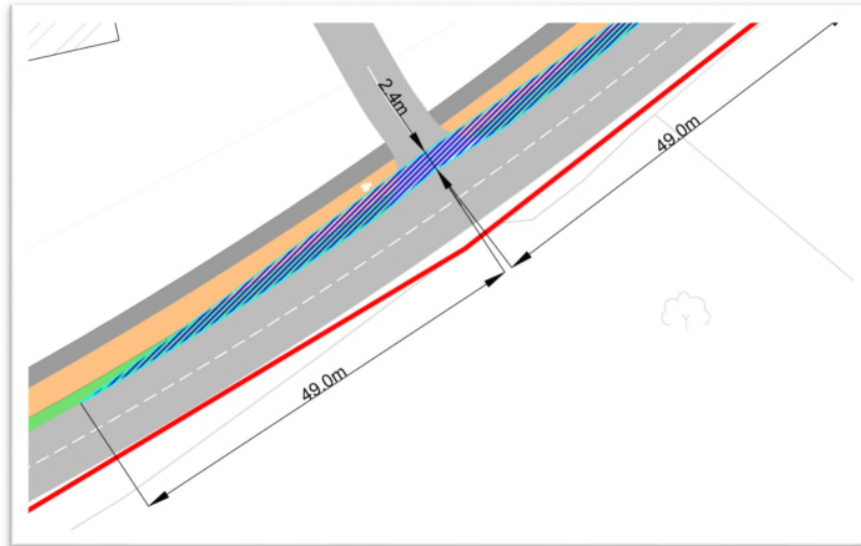
3.5 Problem

Drawing S665- OCSC-1A-MH-DR-C-0115 S2 P01, Visibility Splay at Campus junction.

The visibility splay is shown for a 50km/hr urban design speed. The posted speed is 80km/hr. There may be insufficient visibility to oncoming vehicles leading to side-impact or rear-end collisions.

It is recommended that visibility splays be provided to match the anticipated 85th percentile speed post opening.

3.5	N	N	The visibility splay is achieved for 50kph. The speed limited will be lowered to 50kph once the new	Yes

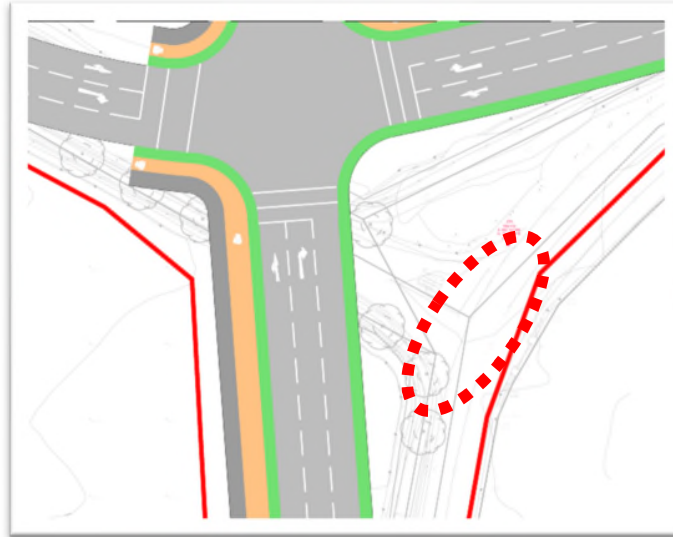
3.6 Problem

Drawing S665- OCSC-1A-MH-DR-C-0111 S2 P01 Sheet 2 of 3, Carton Estate gate.

There is an existing gate into the Carton estate close to the proposed signalised junction. It is unclear if this gate will be used in the future. If it is to be used movements into and out of it may lead to collisions at the junction.

It is recommended that the accommodation works relating to this gate be included in the design process.

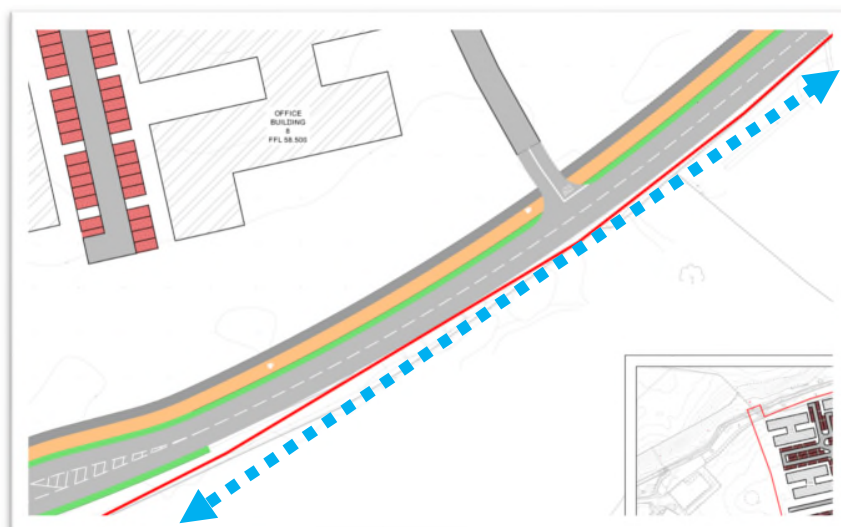
3.7 Problem

Drawing S665- OCSC-1A-MH-DR-C-0111 S2 P01 Sheet 2 of 3, Carton Estate boundary wall.

The realigned R157 eastern arm is very close to the stone wall of the Carton Estate. This is a hazard for an errant vehicle.

It is recommended that a suitable Clear Zone be provided between the boundary wall and the realigned carriageway.
